Survey Report No.: 2024-01003

FEBRUARY 5, 2024

RE: CONDITION AND VALUE SURVEY
 M/V "BARBARA LYNN"
 RMB Marine Services, LLC
 Florence Harbor / Florence, Al.

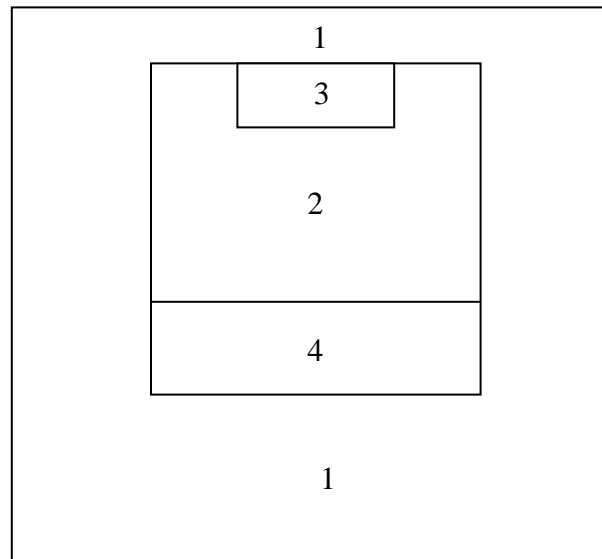
WHEELHOUSE DECK DIAGRAM

The wheelhouse deck exterior and interior were found to be in generally fair condition with exception to rust and rust blisters under the rubber gaskets and aluminum frames of all windows.

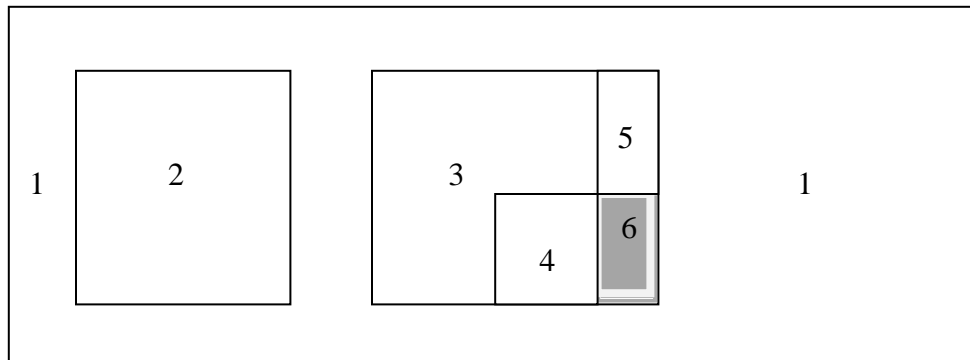
SECOND DECK DIAGRAM

The second deck exterior and interior were found to be in generally good condition with exception to water stains on the bulkhead sheathing to forward, the wooden door to the head coming apart, wood trim around the door in the port bulkhead rotten at the base. The second deck interior was clean with good housekeeping.

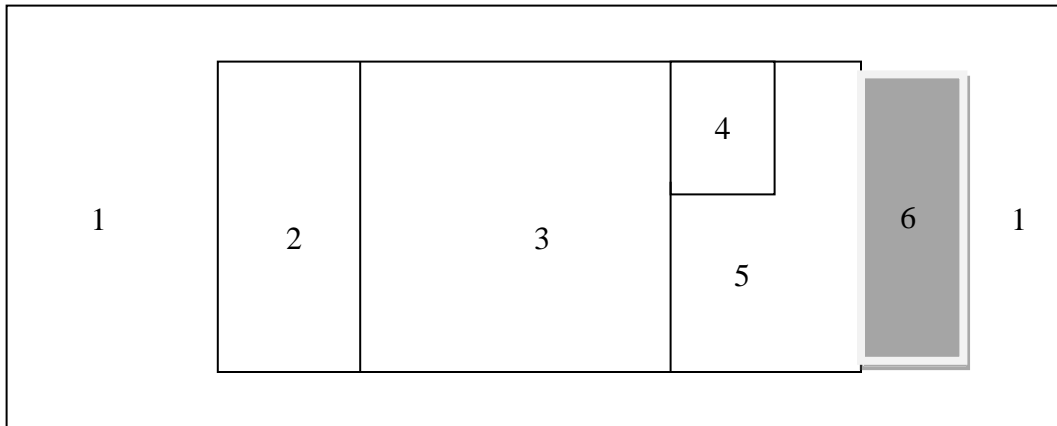
MAIN DECK DIAGRAM

The main deck exterior and interior were found to be in generally good condition with housekeeping about the areas to be in good order.

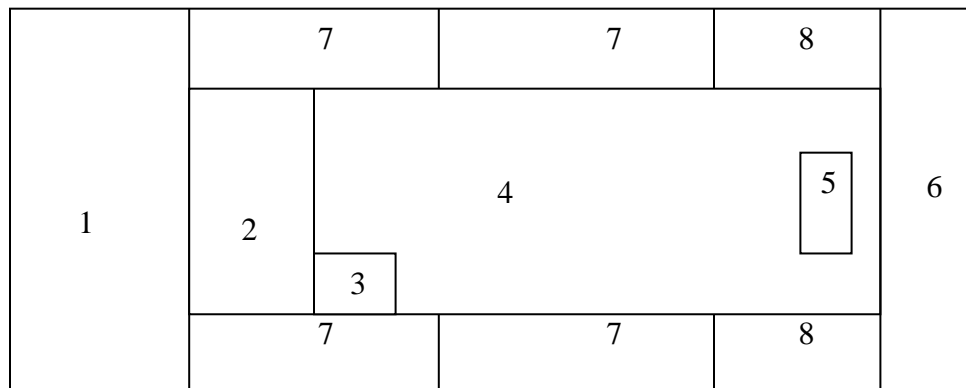
HULL DIAGRAM

Hull plates about the vessel exhibited only random scattered indentations of up to 0-3/4” in depth, with no one area worthy of specific mention.
