Survey Report No.: 2024-01003

RE:    CONDITION AND VALUE SURVEY  
      M/V "RUTH E"  
      RMB Marine Services, LLC  
      Florence Harbor / Florence, Al.

The purpose of survey was to ascertain the general condition and fair market value of Motor Vessel "Ruth E" and establish a record of same.

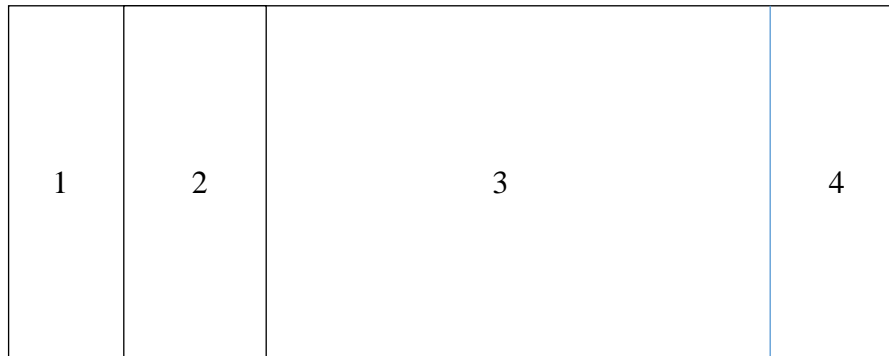
**HULL DIAGRAM**

| 1 | Forward Peak | 3 | Engine Room |
| 2 | Forward Fuel | 4 | Void |
